HARRIS

SERVICE BULLETIN

MW-1/MW-1A

AM-120-LAP
ECN 23812

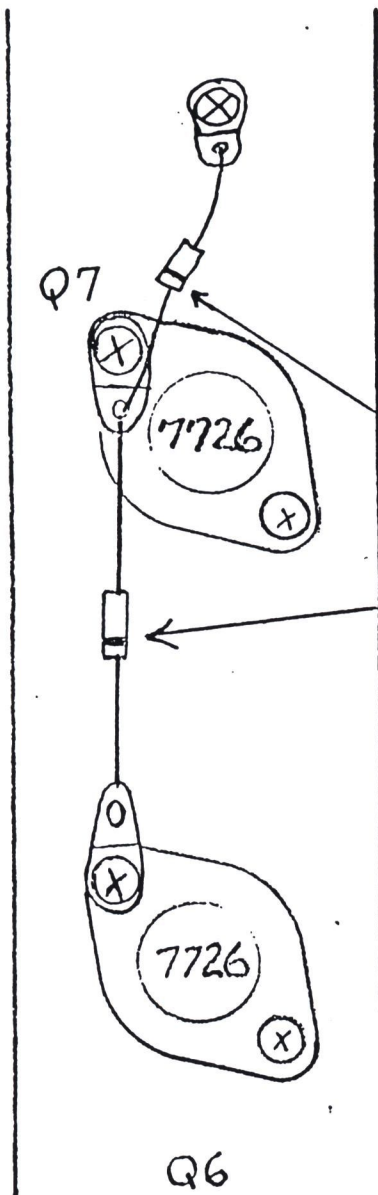
RF Heatsink Assembly

PROBLEMS ENCOUNTERED: Ringing of class 'D' waveform, random and premature loss of Q6 and Q7 in A-1 through A-13 PA module assemblies (992-4201-001), assymetrical PA voltage dip while tuning the transmitter.

The major supplier of these 2N6340 transistors (Motorola) has changed the doping mixture used to manufacture the collector-emitter junction's structure. Thus, the newly created junction characteristics may cause the operational duty cycle to be unstable.

CR1, CR2 have been added as in schematic diagram

1CR-1 and 1CR-2 (25 nanosecond reverse recovery time diodes) have been added across the emitter collector of Q6 and Q7; A-1 through A-13.

Place solder lugs under transistor mounting screws as shown in attached drawing. Cut both 1CR-1 and 1CR-2 diode leads approximately the same length. Dress leads carefully, making sure they don't come in direct contact with other components. Be sure to heat sink carefully the diode leads when soldering.

This modification is mandatory when using or replacing Motorola 2N6340 transistors manufactured, starting with 7739 and later. The date code is stamped on each transistor and is read as 7739 (77 year, 39 week). However, we recommend this improvement be made in all PA modules using transistor sockets, so that transistor life and performance may be improved when the above problems are encountered.
