SERVICE BULLETIN

AM-109-KDL Bulletin No. Date October 25, 1976

Equipment: MW-5 AM Transmitter

Subject: Additional Maintenance and Troubleshooting Information

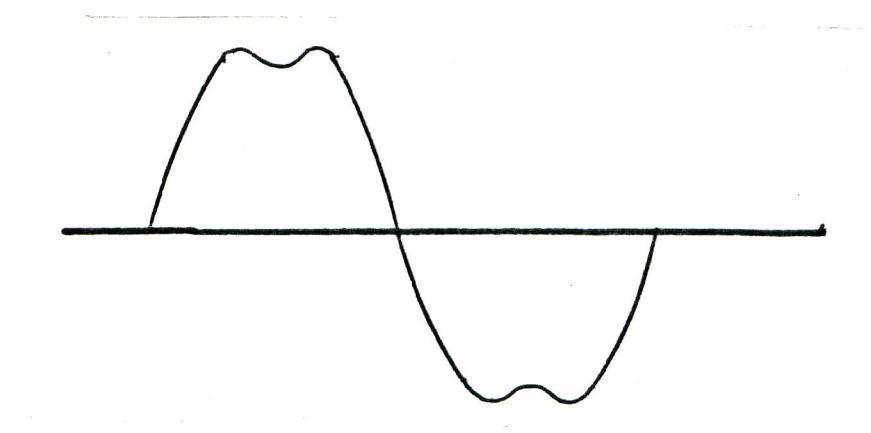
- Perform the adjustment procedure outlined in sections 4.3(17) through (19) on page 4-6 of the MW-5 Instruction Book. If tuning and operation still does not seem normal or an obvious component failure has occurred, further effort is required.
- 2. Drop a small oscilloscope probe (connected to the 'scope vertical input) through the grating above the PA tube and connect the ground clip to the grating. Observe the PA plate waveform at an RF sweep rate. It should look something like that shown below if operation is normal.

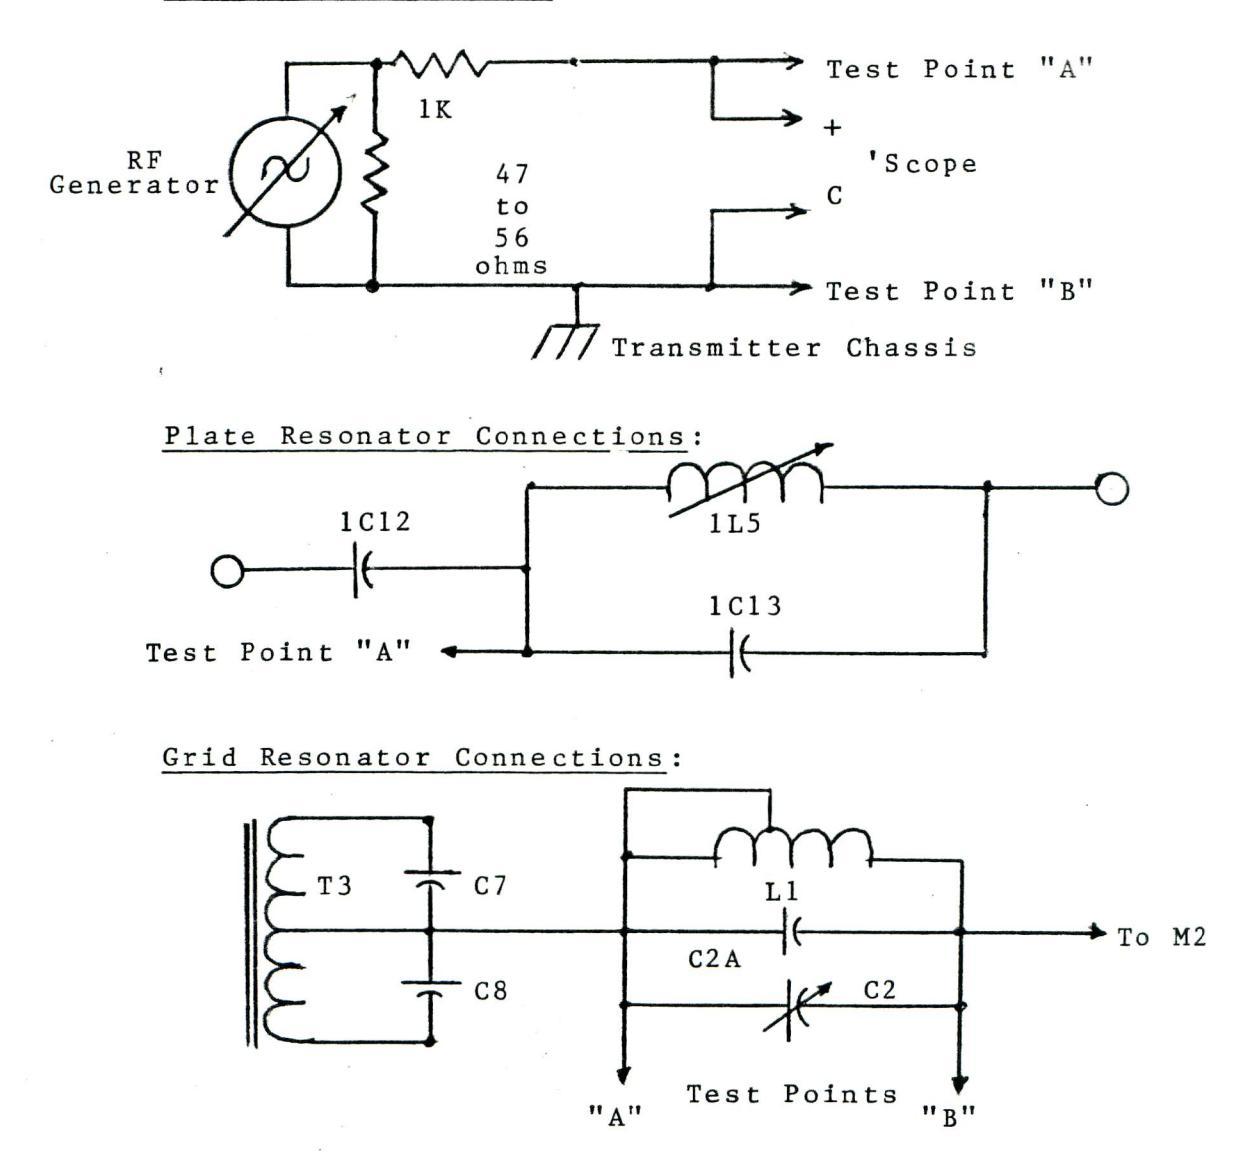
General Test Circuit:

3. Find the setting of the resonators by the following method: Set up an RF generator, clip leads, resistors, and the 'scope as shown in the diagrams below. Vary generator frequency until a response peak is noted; determine the generator frequency at that point. It should be within ±200kHz. of the third harmonic of the assigned carrier frequency. If not, adjust the generator to the third harmonic and adjust the resonator for a response peak. In the case of the grid resonator, it may be necessary to change the tap on coil lA3Ll one turn either way to place grid efficiency tuning capacitor lA3C2 within range.

*all components have 1A3 prefix for grid circuit

- Repeat the efficiency optimization procedure of sections
 4.3(17) through (19) on page 4-6 of your Instruction Book.
 A waveform similar to that in (2) above should now be noted.
- C. Optimization of Harmonic Distortion
