## SERVICE BULLETIN

Bulletin No. AM-148-TAB
Date May, 1980

Equipment: MW-5/5A

JECT: Procedure for Installation of Protective Shield

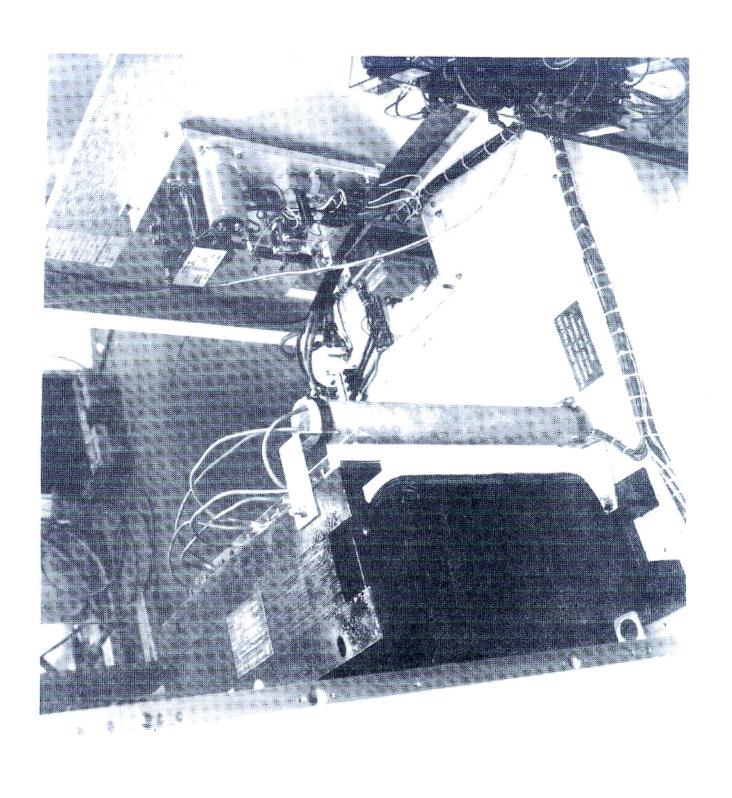
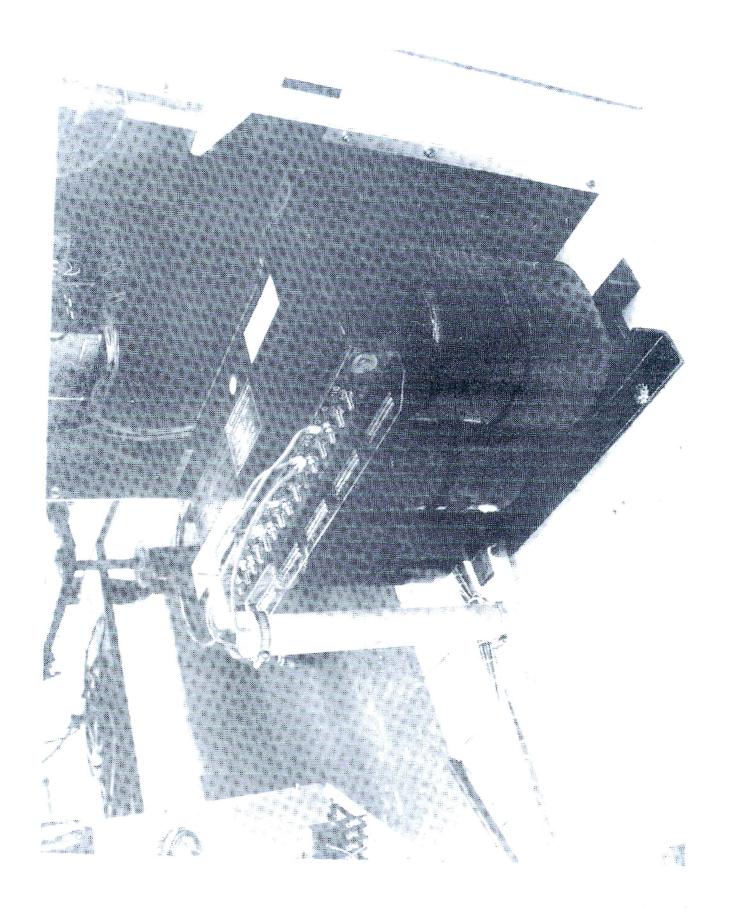
PURPOSE: The purpose of this modification is to dress the

primary AC wires of the high voltage transformer in a manner that will not permit them to make contact with

the core of the transformer.

- Remove all wires from primary of HV transformer (after making diagram).
- 3) Connect mounting bracket to top right side of transformer using the supplied bracket, bolt, washer and nut. Leave bracket loose at this time to allow movement. (See Photo)

- 5) Install the clear plastic shield over the primary connections of the transformer and secure in place with the bolts just removed. Use nylon washers and large steel washers supplied in kit. (See Photo)

- 6) Remove lower right hand mounting bolt on HV transformer and install second mounting bracket. (See Photo)
- 7) Cut tie wraps which secure primary wiring to main cable harness. Cut only enough tie wraps as necessary to swing primary wiring to brackets mounted on right side of transformer.

- 8) Slip protective tube over primary wiring and fasten tube to mounting brackets with hose clamps supplied. (See Photo)
- 9) Reconnect all primary wiring to transformer.
